Impact of Land Use on Water Quality of Phewa- Lake Pokhara, Nepal

Rudra Bahadur Raya

**Centre for Socio Environment
Conservation Nepal (SEC-Nepal)**

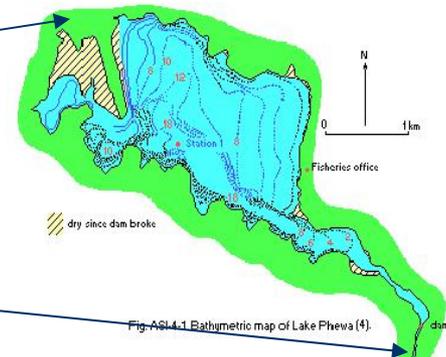
Fig-AS1.4.1 Bathymetric map of Lake Phewa (4).

Phewa lake

3.3.1 Bathymetric map

- Bathymetric map of the reservoir was prepared based on the February 2006 data (because no any new data is found in Nepal) at the scale of 1:10,000 using 1 meter contour interval and is given in figure 4 with reference to the highest water level (794.15m), the area of the reservoir is about 439 ha
